CONTAMINATED SITES 2018

Case Hystories of contaminated sites remediation and sediment management in Italy: technology and results

Giovanni Preda

Trevi S.p.a., Italy

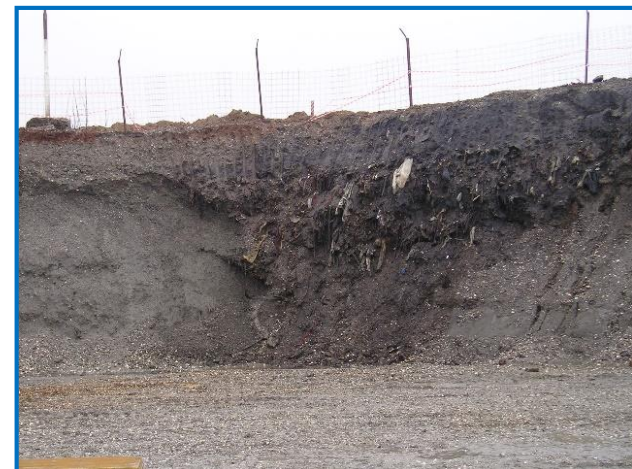
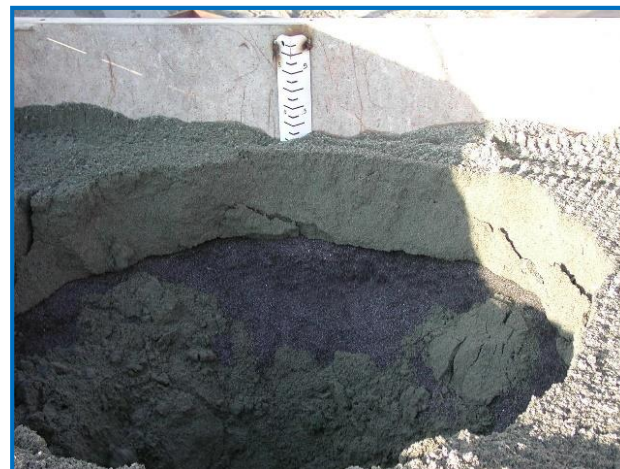
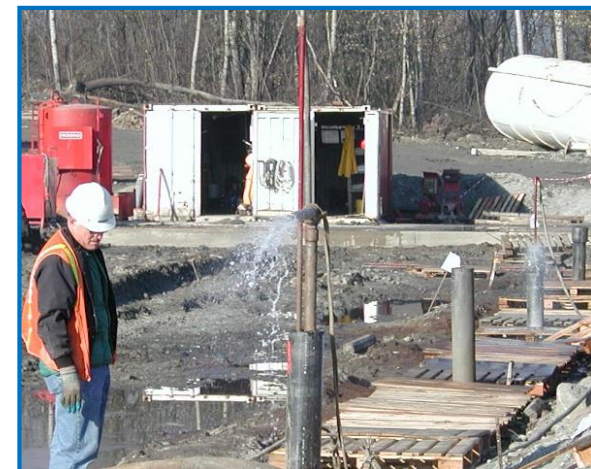
The PRB was realized to remediate a chlorinated hydrocarbons plume at an old industrial landfill site, in Avigliana, near the city of Torino, in the Piemonte Region.

The dimensioning of the PRB was conducted by means of a three dimensional flux and multispecies contaminant transport model based on column degradation test.

The excavation of the 120 m long, 13 m deep and 0.6 m thick barrier, was performed in just 8 days using a crawler crane equipped with a hydraulic grab and supported by guar gum slurry. After the excavation, the trench was backfilled with 1700 t of iron and the biopolymer degraded using enzymes.

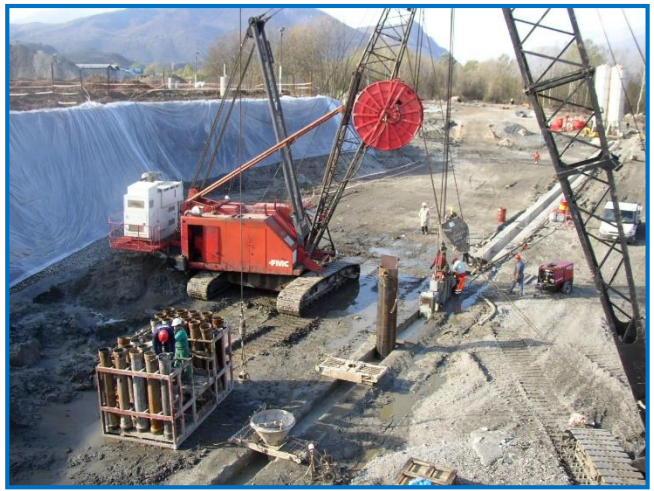
Permeable Reactive Barrier (PRB)

The excavation was realized using a crawler crane equipped with a hydraulic grab and supported by guar gum slurry until the backfill with ZVI.

The construction was performed by means of 17 panels whose average length was 7 m.

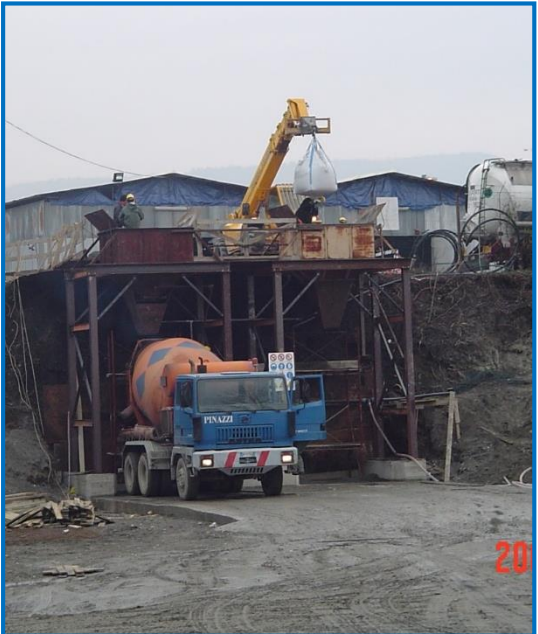
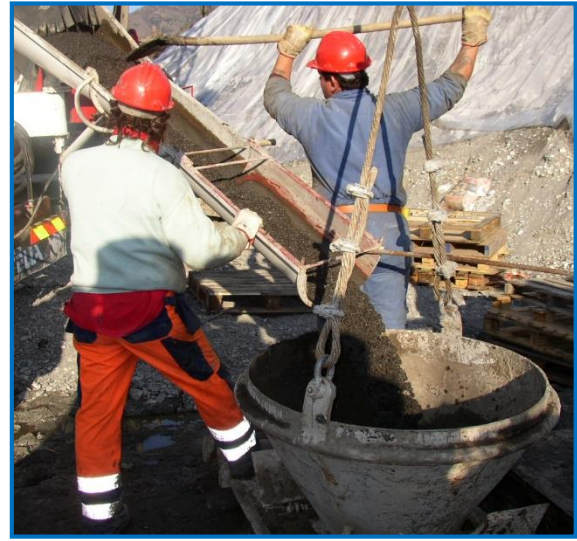
Permeable Reactive Barrier (PRB)

The residence time of groundwater inside the reactive cell is enough to decrease CAHs' concentration below clean-up goals, maintaining a good safety margin.

Output concentrations are largely below the limit of 30 µg/l of total carcinogenic compounds and also carcinogenic CAHs are below detection levels.

Reaction byproducts (VC, 1,1-DCE, 1,2-DCE) are nearly absent both inside and downgradient the PRB and this proves that the barrier is able to perform a complete dehalogenation process.

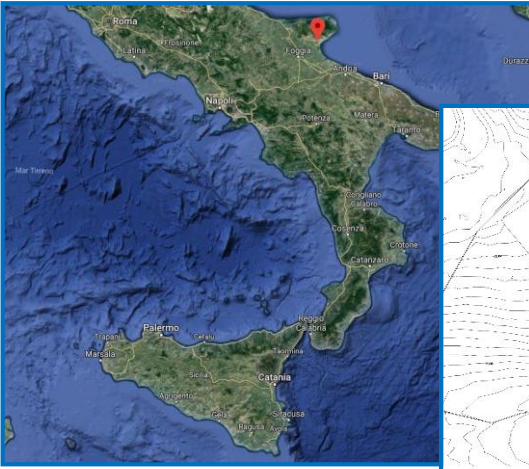
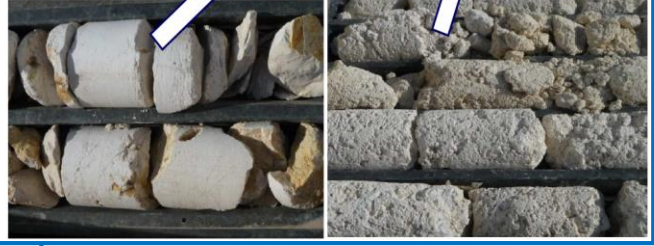
The landfills are located in an area characterized by numerous gorges (small canyons) of erosive origin. The collected data show a 25-40m layer of soft rock (calcarenite). The calcarenite has macro-fissures that create a high (local) increase in conductivity. Calcarenites lie over a formation of whitish or pink limestone (calcilutites), well- stratified and highly fissured.

The construction of a screen through traditional techniques would have required thousands of vertical drillings crossing the waste to reach the rock layers to be injected.

Intervention based on the Horizontal Directional Drilling (HDD) techniques, which are widely used in the oil industry and for the installation of underground utility services, properly modified and integrated, TDDT: Trevi Directional Drilling Technology made it possible to drill sub-horizontal curvilinear boreholes up to 180m.

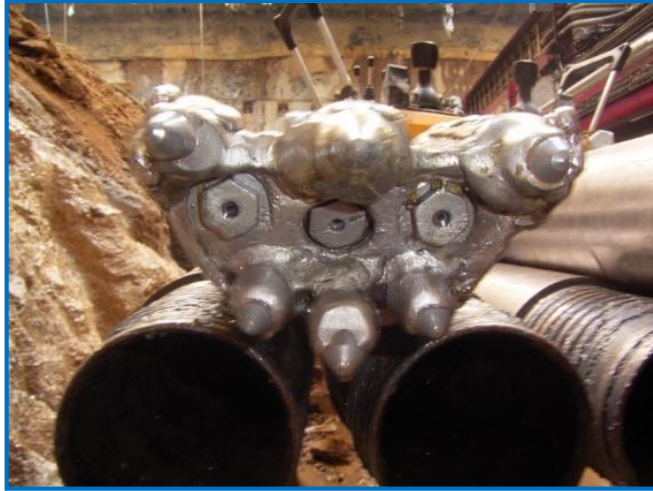
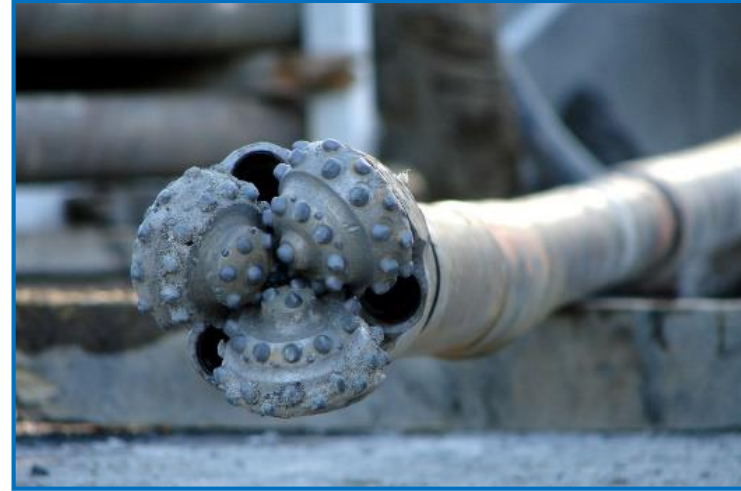
So what's TDDT?

TDDT (*Trevi Directional Drilling Technology*) is a set of technology that enables drilling of small diameters (50 – 200 mm) and long (from 25 m to a few hundred meters) boreholes with high-accuracy positioning (10 - 30 cm) for a wide range of applications.

If diameter and thickness of rods/pipes allows it, drilling can be either rectilinear or curvilinear, executed in all directions and in any soil type, including rocks.

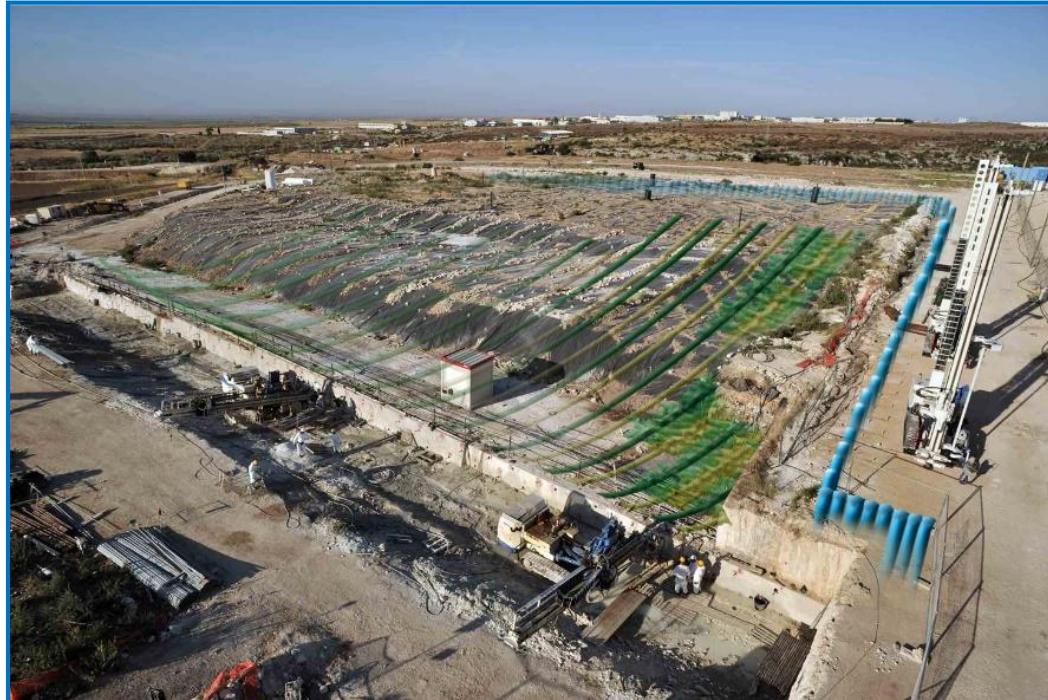
Remediation of former landfills in Manfredonia (South Italy)

The directional drillings were performed from one of the sides of the landfill, intersecting the vertical perimetral screen. Steel sleeve port pipes were placed inside the boreholes for cement and silicate mix grouting.

Project specifications required a drilling directional accuracy of 30cm.

The screen was specially sized to match the contour of the landfill bottom and to be placed at a 2.5-3m distance from the waste bottom, seamlessly joined end-to-end to the perimetral barrier. The rock was treated along a thickness of 3 m.

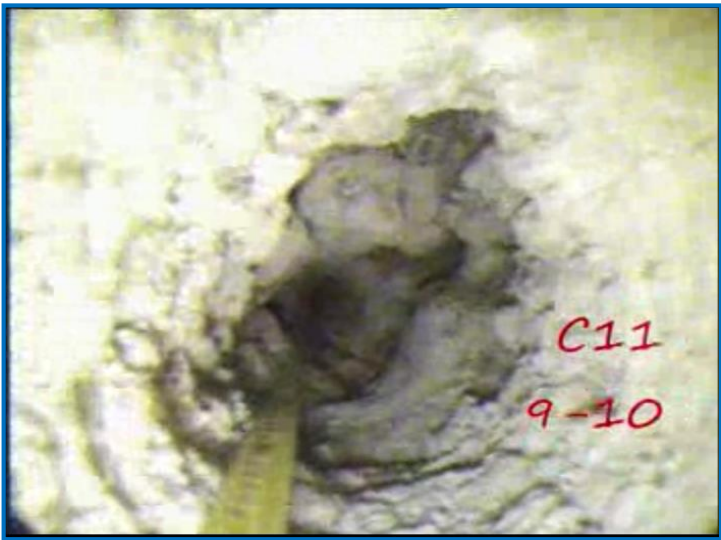
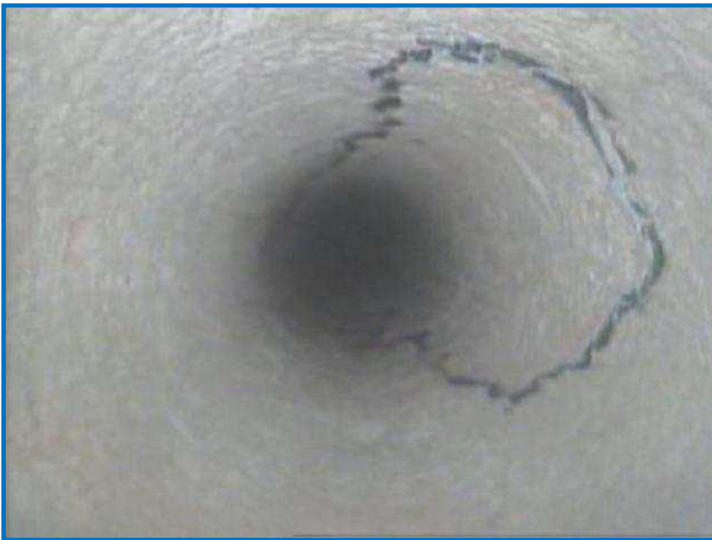
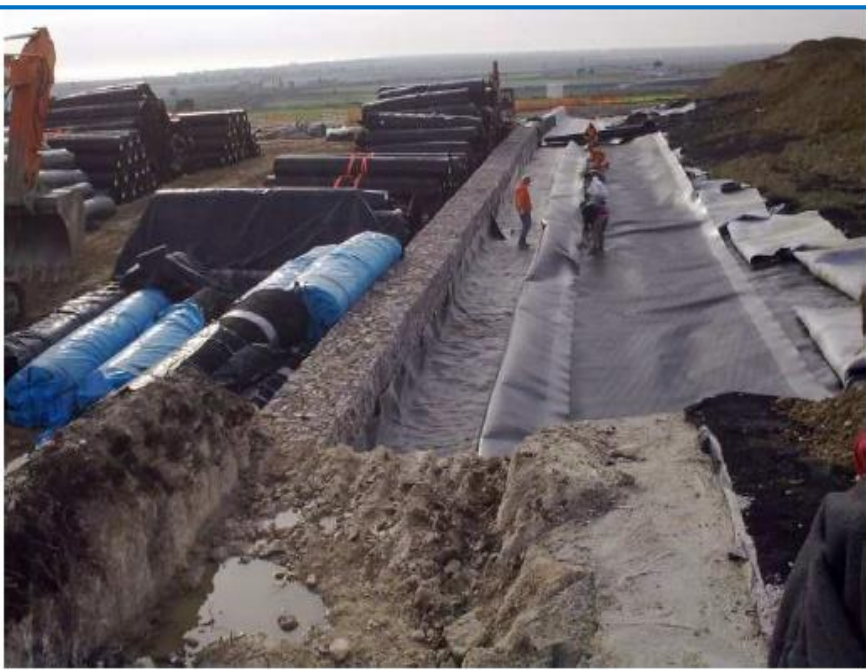
Encapsulation of contaminated soil under leaking tanks (North Italy) **TREVI**Group

The intervention was aimed to substitute a volume of contaminated soil and to encapsulate another volume under leaking tanks inside a petrochemical multi-company site, 4.5 kilometers away from the city center of Ravenna.

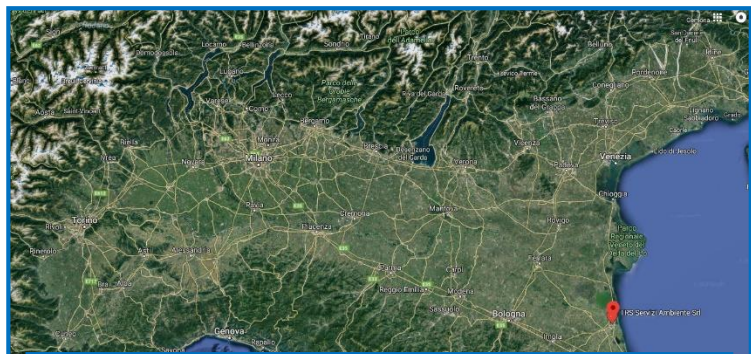
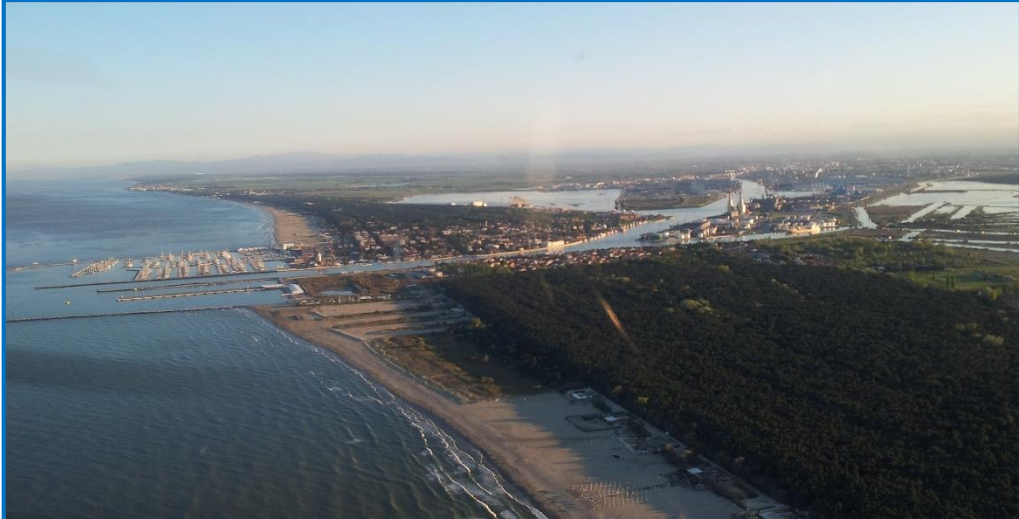
The intervention mainly consisted in the construction of a diaphragm wall around the area occupied by the containment basin of 4 tanks filled with MtBE (metil-t-butil-etero, a chemical compound used as antiknock instead of other additives based on lead) and methanol.

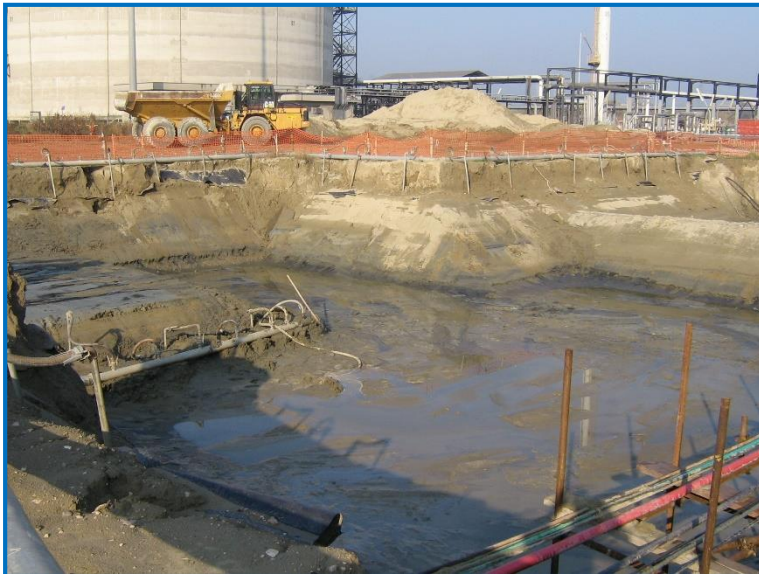
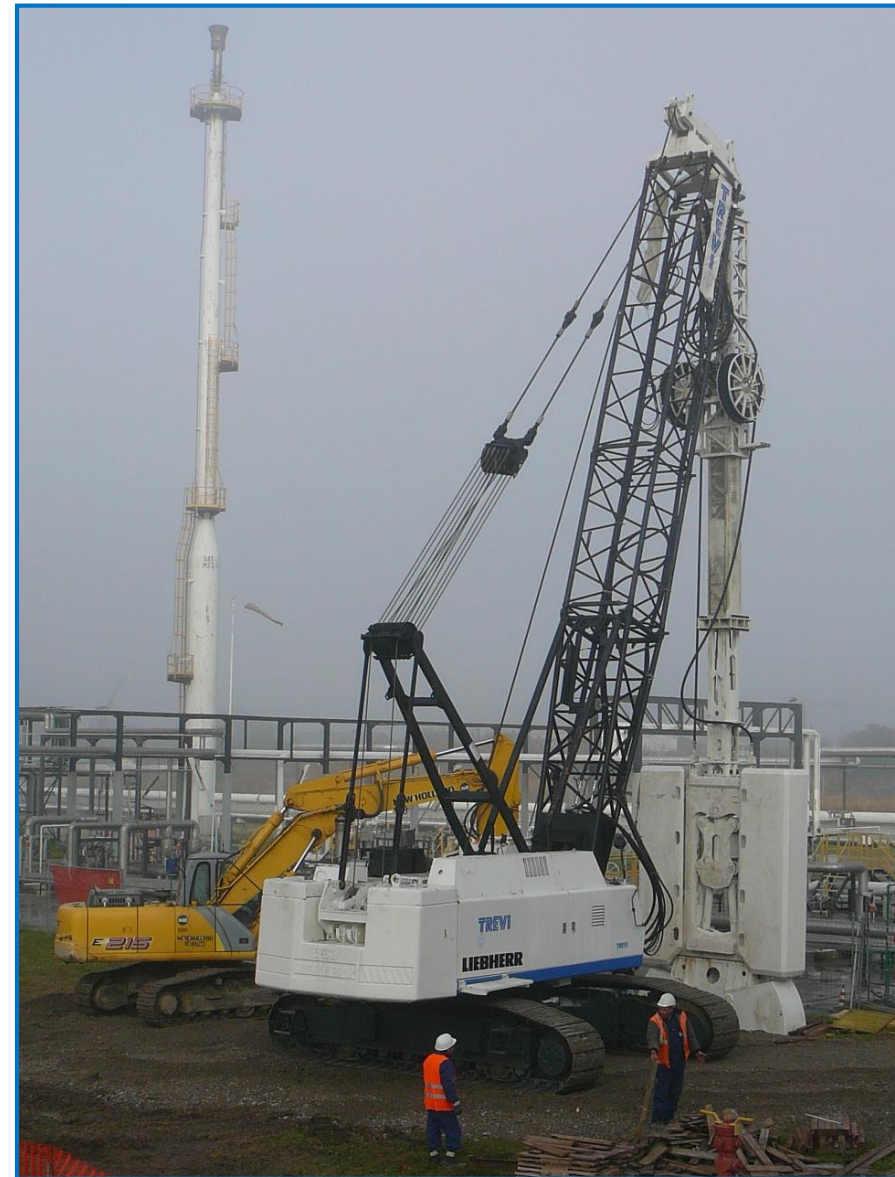
Encapsulation of contaminated soil under leaking tanks (North Italy) **TREVI** Group

Works basically consisted in a slurry wall. This barrier – whose total length was 460 meters – was executed with a plastic diaphragm wall with a HDPE layer along 445 meters and, for the remaining 15 meters, through jet grouting column treatments. The vertical barrier was embedded 3 meters down into the clayey layer located at about 30 meters from ground level.

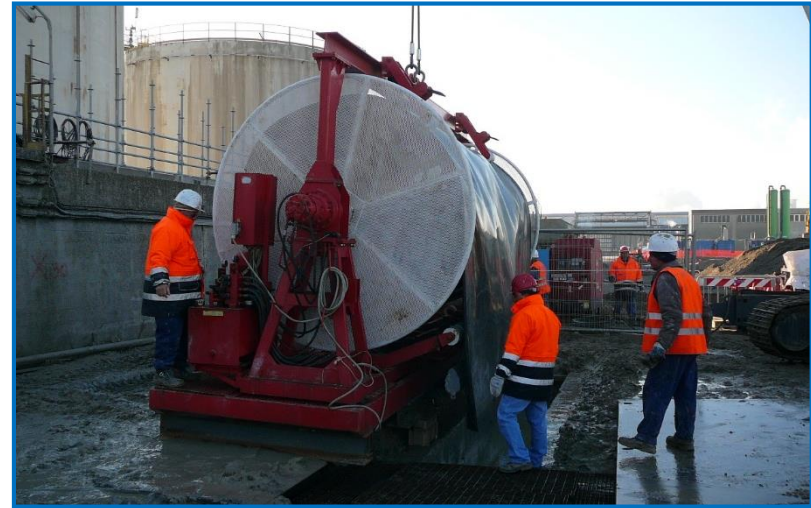
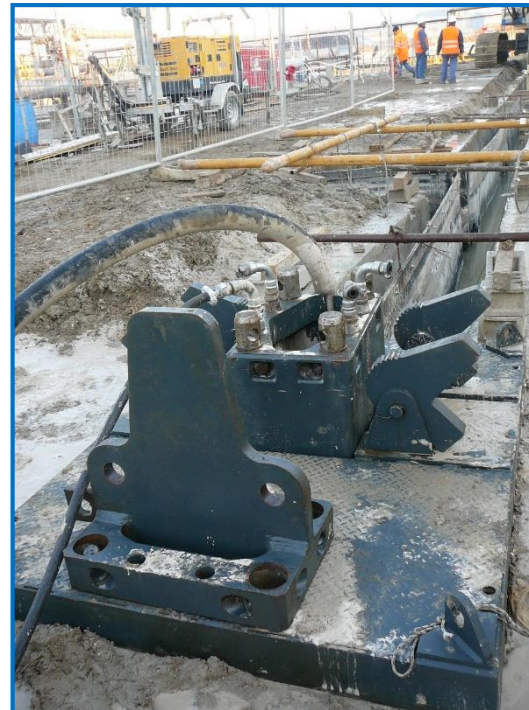
Encapsulation of contaminated soil under leaking tanks (North Italy) **TREVI**Group

The following techniques were used for the project:

- Continuous 80 cm thick slurry wall made by pre-mixed self hardening grout and HDPE layer at a maximum depth of 33 meters. (Execution of 13.350 m²)
- Plastic cut-off wall with secant jet grouting columns with a diameter of 1000 mm. The jet grouting section has a length of approximately 420-450 m with a minimum thickness of 4.6 m.
- Site covering through capping complying with the D.L. 36/2003, made up of different layers (Regularization layer, thickness greater than 5 cm; HDPE layer, thickness 1 mm; Bentonite geocomposites; Protection geotextiles; Reinforced concrete layer, thickness 15-30 cm).

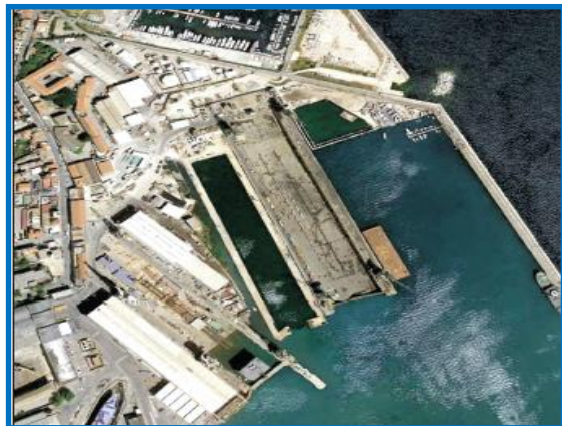
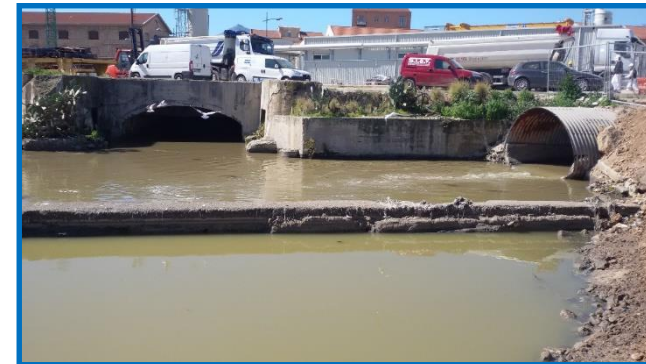
At the end of the 80s Palermo Port Authority started works to construct the 150.000 DWT Dry Dock, within Palermo Industrial Port. Works were stopped due to a dispute arisen with the Subcontractor.

Works specified in the Contract included dredging of approximately 76.000 m³ of sediments and waste, for a total of about 117.000 tons of mainly sandy material, contaminated by hydrocarbons C>12, heavy metals and mixed waste, mostly conveyed by 2 sewage pipes (about 500.000 EI) which, until 2014, would discharge next to the Dock.

Once the works were finished, approximately 111.000 tons of waste were treated, recovering 41.400 tons of sand, 15.200 tons of gravel, while 25.400 tons of contaminated fine fraction were disposed of in an external plant.

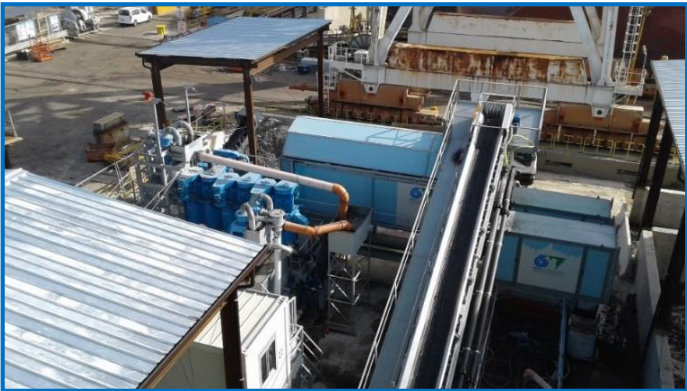
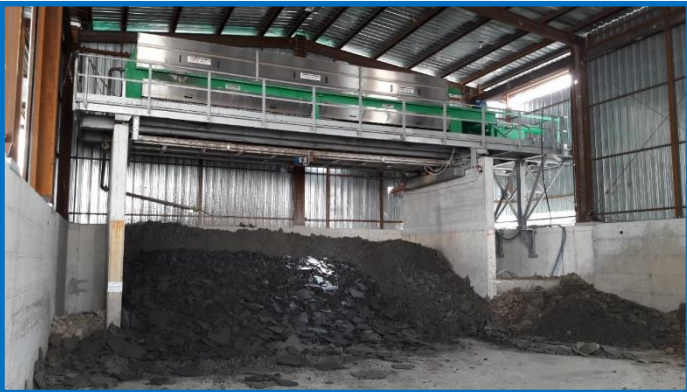
So what's Sediment Washing?

The objective of the Sediment Washing treatment is the recycling of materials and subsequent reduction of waste to be disposed of. This technology, if properly applied, always reduces the amount of waste to be recycled/disposed of in external plants; for that reason it can be considered environmentally sustainable and developed in compliance with waste management regulations (Art. 179 of D.Lgs. 152/2006).

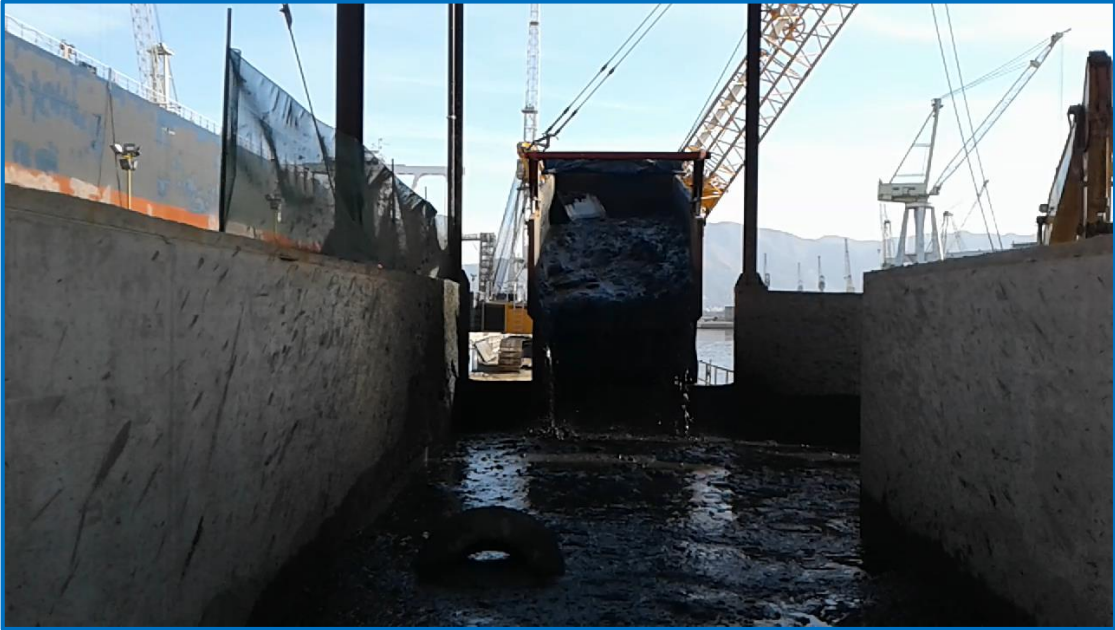
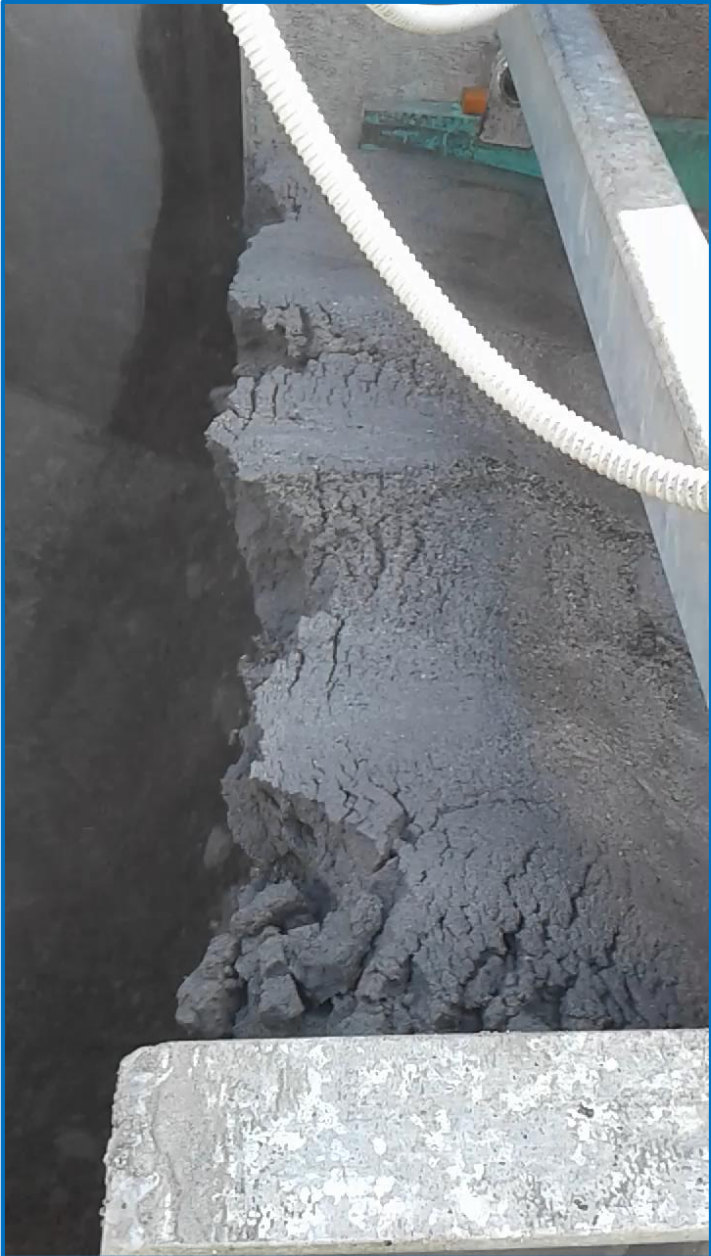
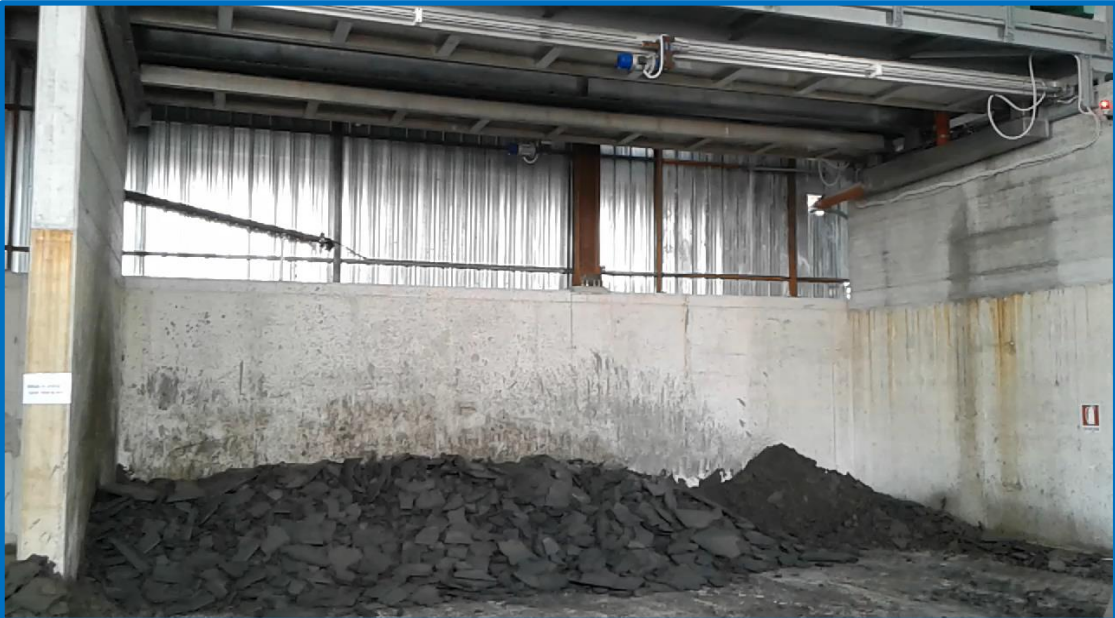
The plant has recovered material - R5 “Recycling/recovery of other inorganic substances” – from the waste’s sandy and gravelly fraction ($\Phi > 0.063$ mm), according to previously designed specific purposes.

After undergoing a compliance audit at the jobsite, the sand achieves CE certification as recycled aggregate satisfying the technical requirements for the specific purposes, regulations and existing standards applied to products.

• Recycled material: 51% of the incoming waste
 • Waste dumped: 30% of the incoming waste (reduction of about 70%)
