# CONTAMINATED SITES 2018

# Methods of Contamination Spread Estimation on Nubarashen POPs Burial Site - Armenia

Boris Urbanek

GEOtest, a.s.; Czech Republic

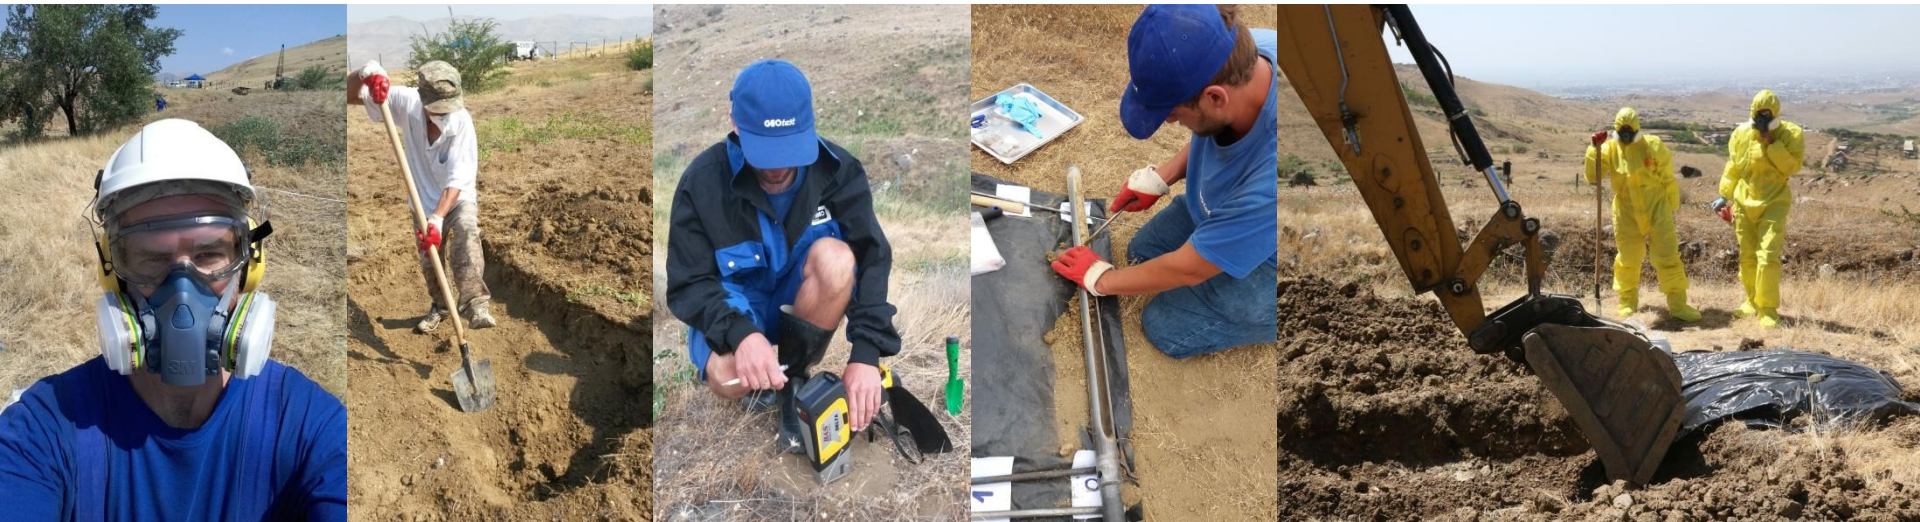
**Contamination survey:** based on the approved sampling plan, in total **30 probes**, **5 trenched pits**, **20 surface collection points** were installed and **ca 200 field XRF** measurements were conducted in the following scope:

- 15 probes into individual cells of the landfill to the depth 2.5 – 3.5 m from the landfill surface level (geological and contamination documentation, **sampling for screening analysis – 5 mixed samples and analysis, sampling for contamination spreading – 6 stratified samples and chemical analyses**);

- 15 probes in the close vicinity of the landfill to the depth 1.8 – 2.0 m (geological and contamination documentation, sampling for stratification of contamination – **57 stratified samples and chemical analyses**);

- 20 surface samples collected from the wider vicinity of the landfill body to the depth 0.1 m (contamination documentation and sampling for contamination spreading – **20 chemical analyses**);

- 5 trenched pits (geological and contamination documentation, sampling for further technological tests); and
- Field measurements using an X-ray Fluorescence (XRF) spectrometer instrument (contamination spreading and correlation of spectrometry and chemical analysis based on more than 200 measurements).

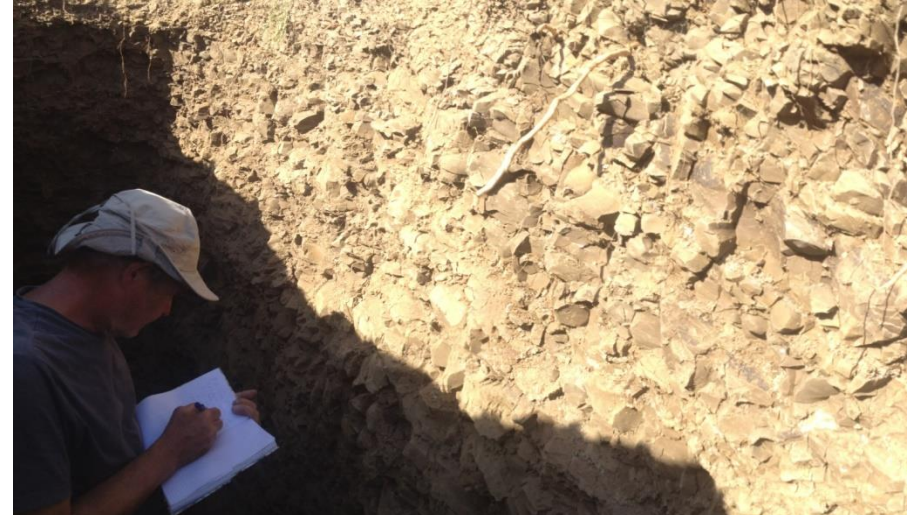
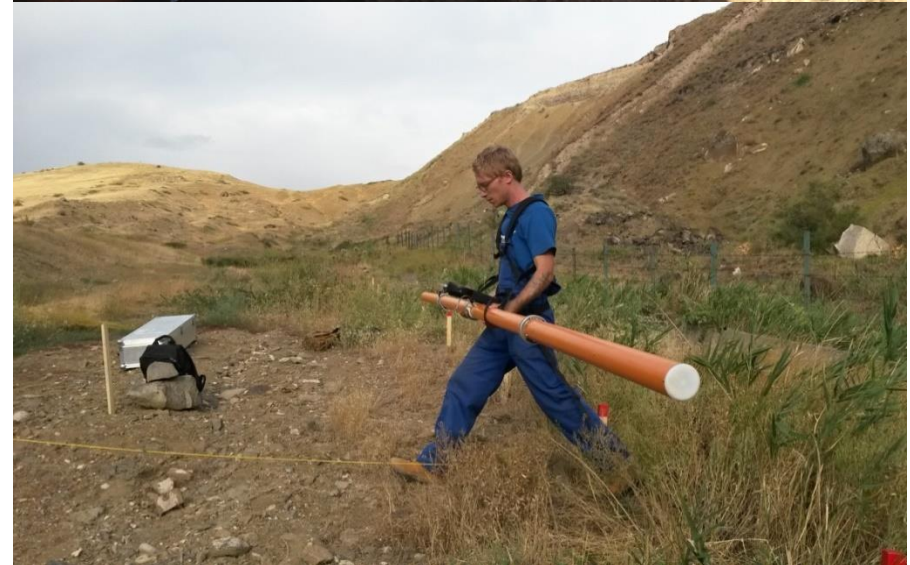
## The **engineering-geological and hydrogeological survey:**

- 13 boreholes drilled, a total depth of 180 m.
- 15 exploration trenched pits.
- Geological documentation of exploratory objects. 35 soil samples for soil mechanics analyses collected.
- Within the engineering-geological mapping of the site - 43 points documented.

## The **geophysical survey:**

- shallow dipole electromagnetic profiling (DEMP)
- specify the location of burial cells and
- to identify the bedrock profile for future construction objects.
- within the fenced area, in total 3,660 m of transversal and longitudinal profiles.
- outside the fenced area, a total of 1,773 m of profiles.

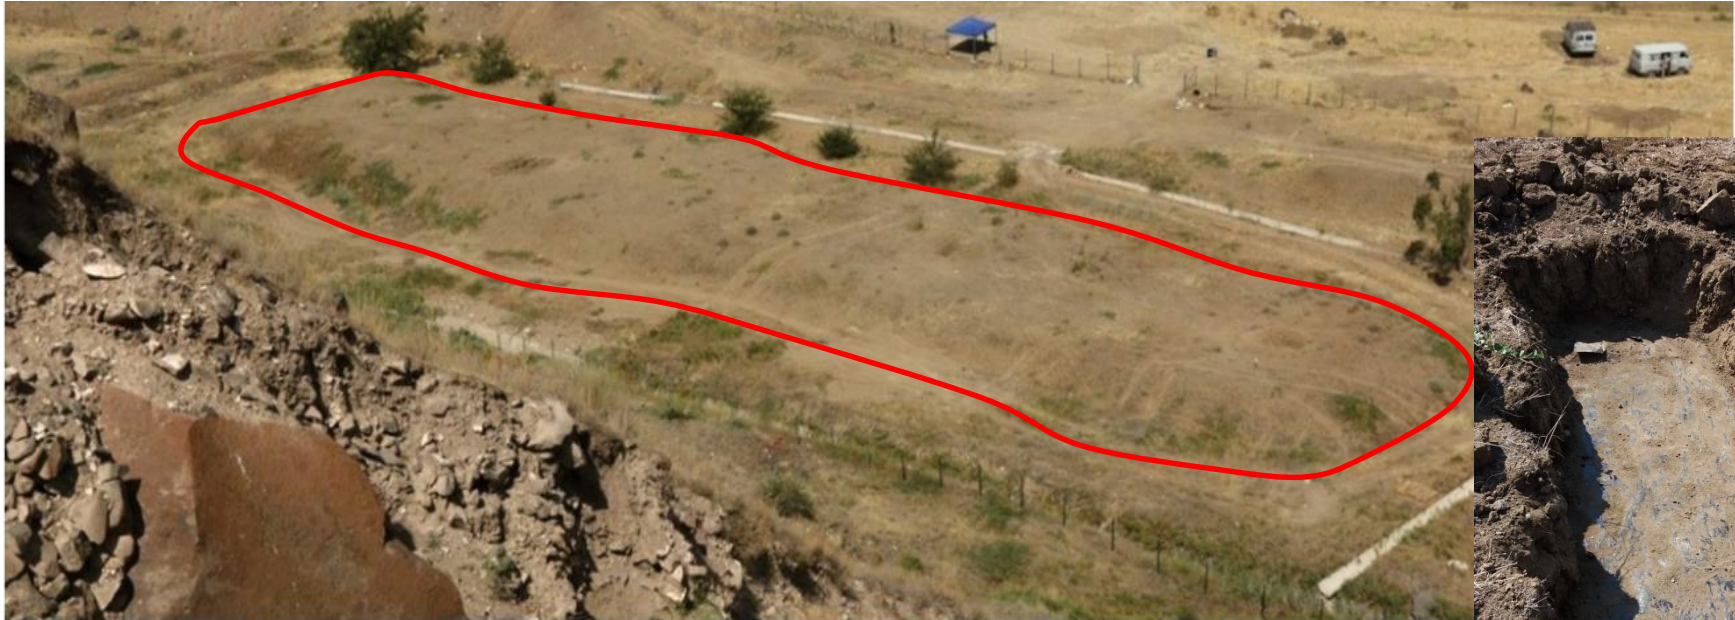
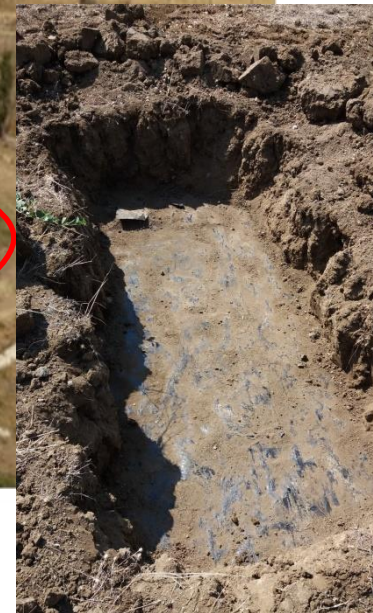
# Results - Recent site contaminating operations

- The landfill was constructed in 1976 as a depository site for obsolete pesticides and other chemicals (POPs).
- The closest non-permanent housing is located ca 300 m at the western and south-western side of NBS.
- The area of the landfill body is ca 0.15 ha (105 x 15 m), maximal expected thickness is 4 m.
- **Unprofessional operations and release of deposited material due the vandalism and illegal excavation of pesticides done into the landfill body in 2009.**
- **The contamination spread is limited to water non-saturated zone, alternatively to creek sediments and surface water**
- The primary contamination is to be expected exclusively in the landfill cells.
- Most of the out-of-landfill contamination spread is a result of unauthorized manipulation with pesticides in 2009 and its reclamation attempts.

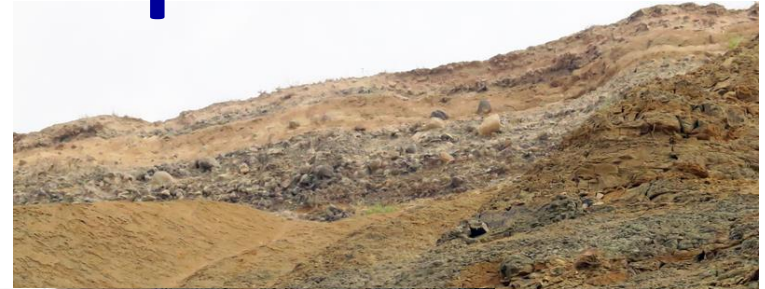
**Quaternary** terrace deposits and alluvial accumulations are widespread in the area

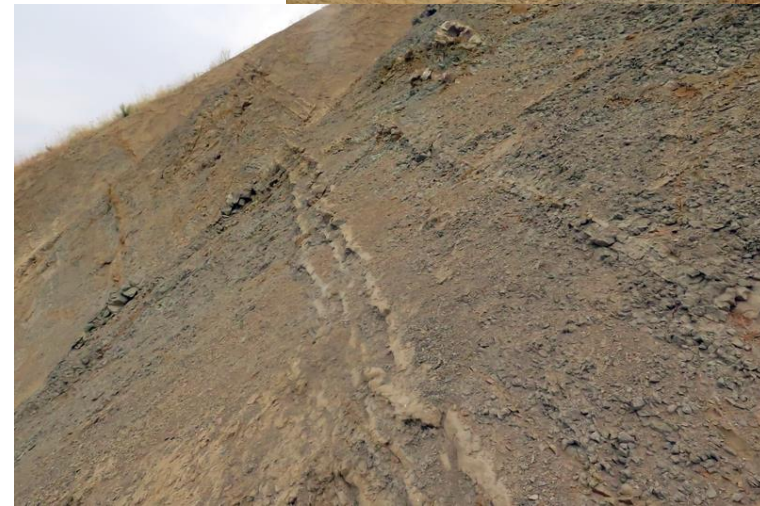
**Upper Pliocene and Quaternary** lava flows cover different horizons of Voghjaberd formation and older rocks. The lava flows have originated in Gegham Volcanic Mountain range.

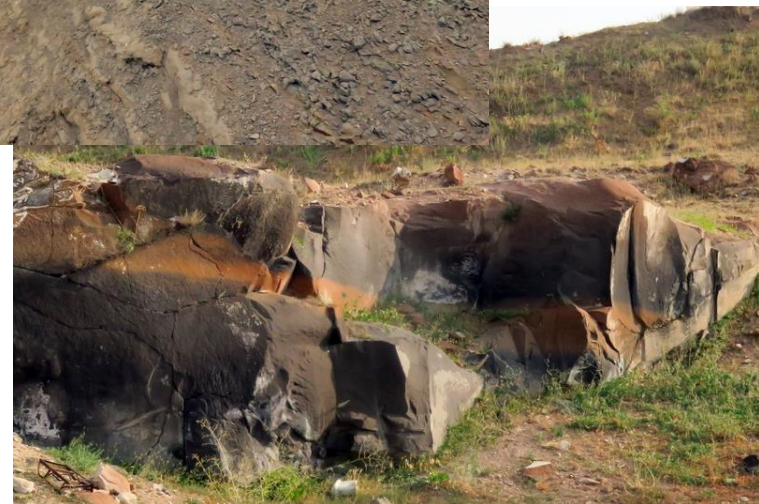
**Lower – Middle Pliocene** is represented with Volcanic formation, formed with various volcanic tuffs, breccias and lava flows, with lesser amounts of alluvial and lacustrine deposits, thickness 300 to 1,000 m.

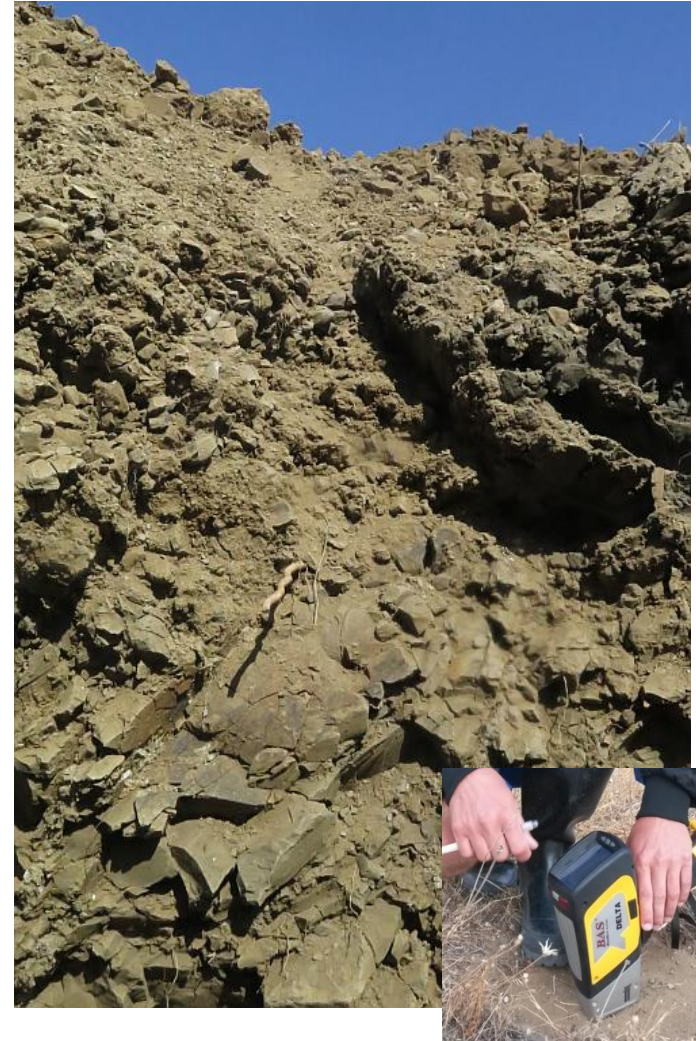
**Upper Miocene:** Hrazdan formation, clays and sandstones, thickness of 1,000 m.

**Middle Miocene:** gypsum-salt bearing formations, thickness > 1,200 m. + minor beds of carbonates and sandstones within it. The clays and salt form the lower half of the formation and gypsum with clays form the upper half.

**Upper Oligocene – Lower Miocene:** Hatsavan formation, clays and continental terrigenous deposits, mostly conglomerates, thickness 430 m and unconformably overlaying the older formations. The conglomerates at the base of the formation.

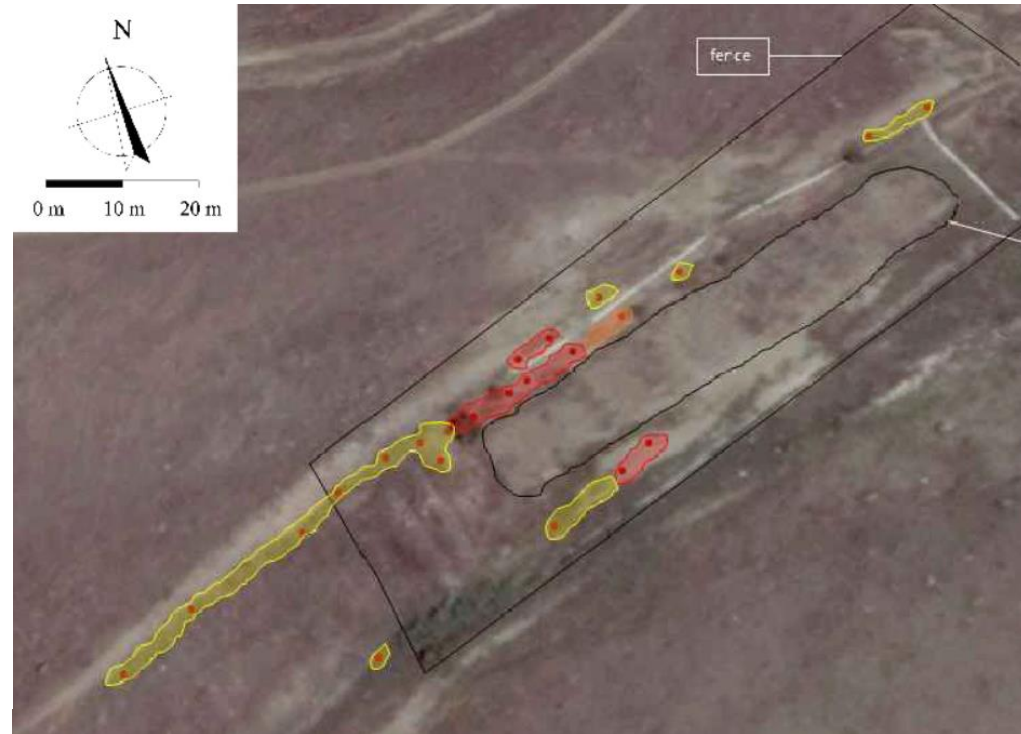
- Verification of presence of contamination on surface, in probes and trenched pits based on correlation with quorum concentrations.
- The results of measurements were correlated with results of natural background measurements and later used for the operational field contamination identification and its rough quantification.
- With knowledge of natural chemical composition of soil on site (quorum), trenched pits between the fence and the landfill body were examined with the portable X-ray fluorescence analyzer Delta Premium (Innov-X).
- Results from X-R measurement were compared with results of chemical analyses - potential correlation was evaluated.

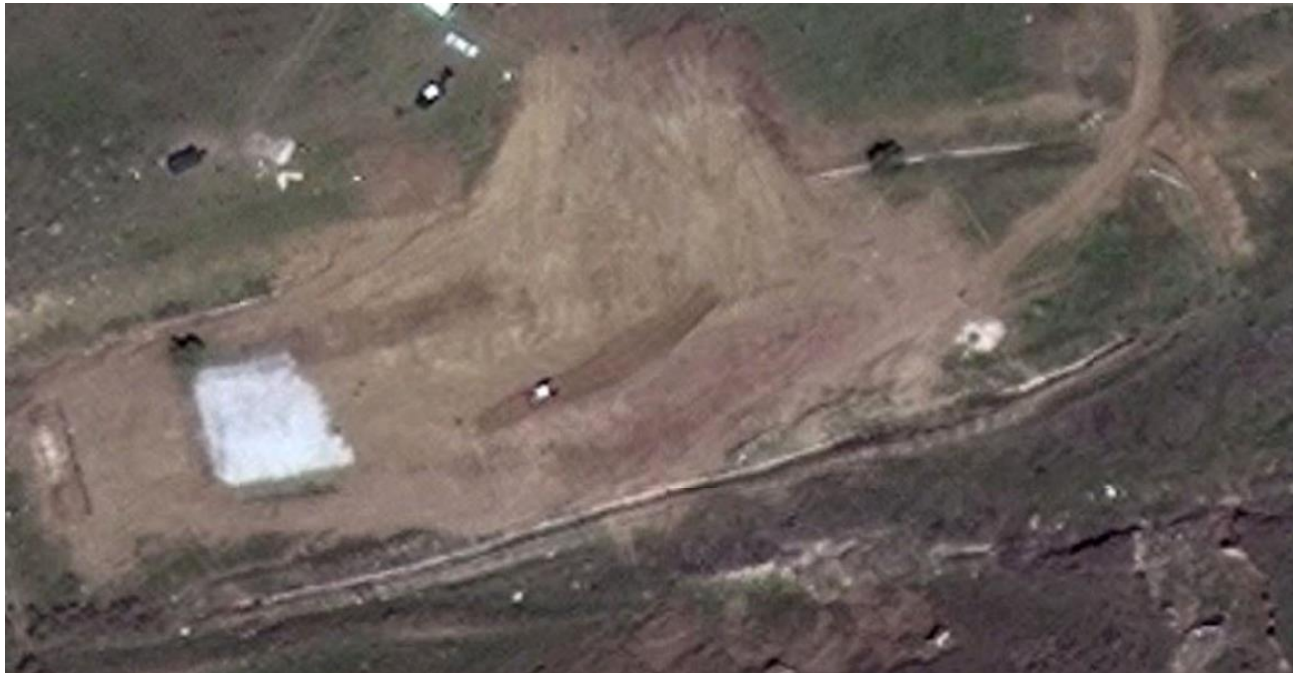
# Site-contaminating operations

- Most of the out-of-landfill secondary contamination spread is a result of unauthorized manipulation with pesticides in 2009 and its reclamation attempts.
- **Mayor amount of POPs deposited show low solubility in water**
- **As a result of such activities, the out-of-the-landfill subsurface contamination is formed by a mixture of various types of pesticides and soil (proved by chemical analyses).**
- **Potential surface contamination as result of air/water/human transport.**

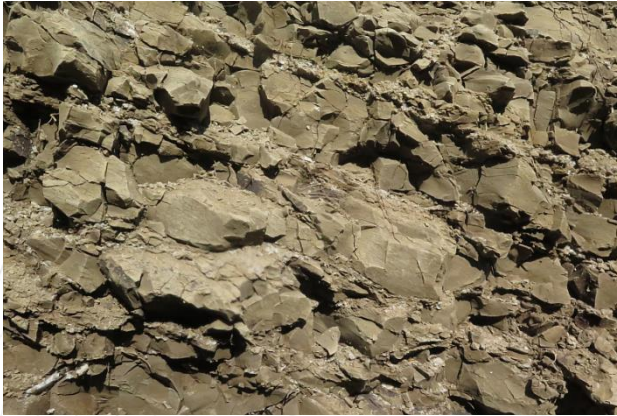
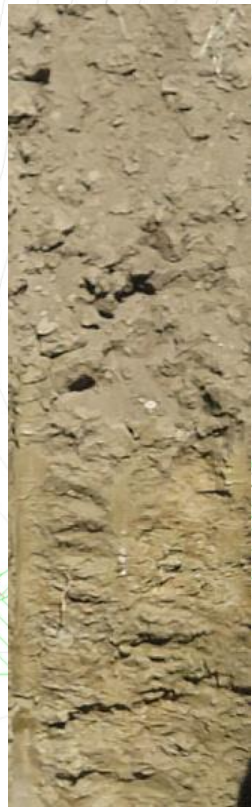
- The **original geological environment** on site is formed by marine/lacustrine sediments with abundant presence of natural gypsum. Clays in its natural state are hard with typical brownish coatings of Fe oxides and gypsum crystals (up to 3 mm). When doing the primary documentation of all survey probes, boreholes and trenched pits, the presence of these indicators were tracked in order to identify the original geological environment.

- This knowledge was later used for delineation of contamination on places with lower density of analytical data implying that the presence of original undisturbed geological profile excludes the possibility of contamination presence.

- Another typical geological feature on the site was a **presence of vertical fractures** formed from the surface of terrain to variable depth levels (2 – 4 m), where **absence of cracks prevent further contamination spreading**. In deeper horizons migration of contamination in natural environment is not expectable because of low solubility of pesticides and low permeability of clays-silts.

- **Therefore, where the analytical data on contamination were missing and the presence of natural geological profile without vertical fractures was documented, the presence of contamination by pesticides was excluded** (supported by X-Ray measurements).

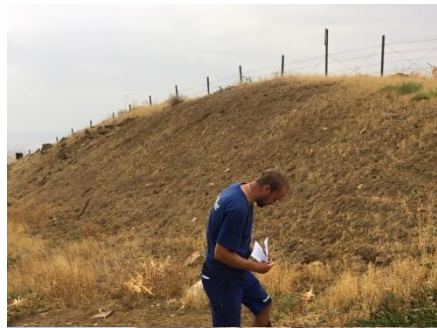
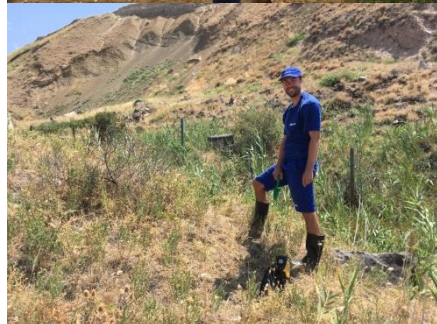
1. In areas of steep slopes between the northern fence and the landfill body, it was presumed that no subsurface contamination (no deeper than ca 0.5 m below ground level) could be present because:
  - no fractures and fissures were documented on the slope (i.e. spreading of contamination by infiltration of surface water is limited because of the quality of soil, also considering a limited solubility of typical pesticides in water),
  - no subsurface contamination was detected on the above-laying plateaus and
  - steep slopes are inaccessible for heavy machinery.
