## **CONTAMINATED SITES 2022**

# Soil and Sediment Capping with Active Geocomposites

Dr.-Ing. Stefan Niewerth
HUESKER Synthetic GmbH, Germany
niewerth@HUESKER.de

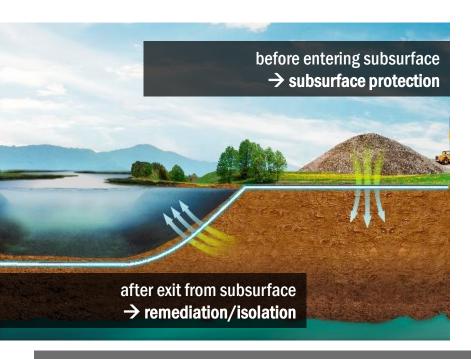
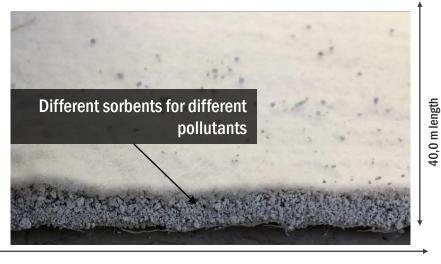
- **Active Geocomposites = permeable contaminant barriers**
- **Barrier to the pollutants not to the water or vapor**
- **Effective where contaminants are spread over wide area (diffuse sources)**

5,10 m width

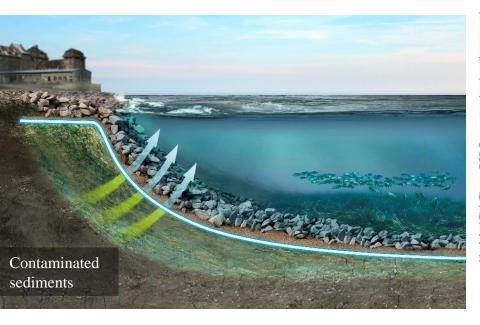
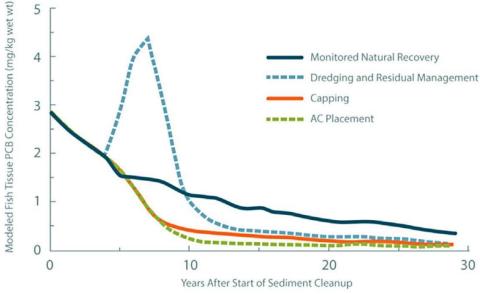
- Cap isolates contaminated sediments but is permeable to groundwater
- **Allows** immediate contaminant reduction and only gentle interference to the environment

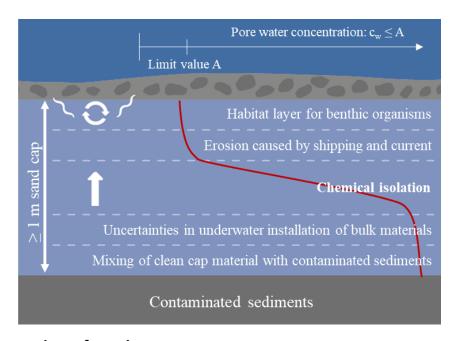
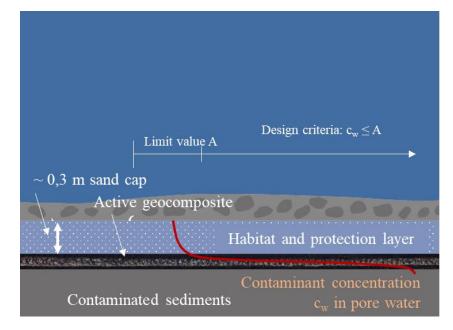
- Sorbents strongly improve chemical isolation compared to sand
- Geotextiles reduce uncertainties
- □ Technical guidelines are available in USA and Norway

$\geq$  1 m of sand

30 cm of sand + 1 cm Active Geocomposite

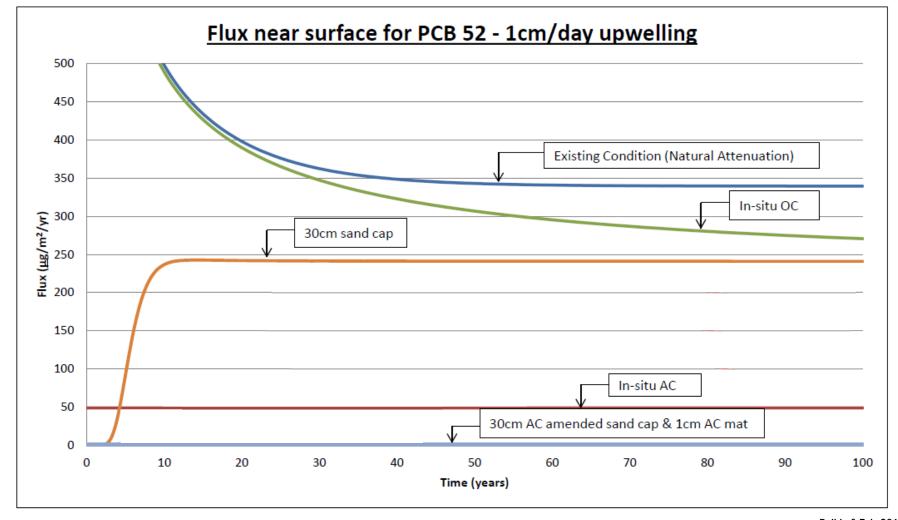
#### **Flux simulation**

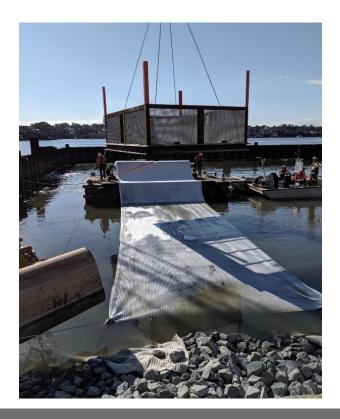
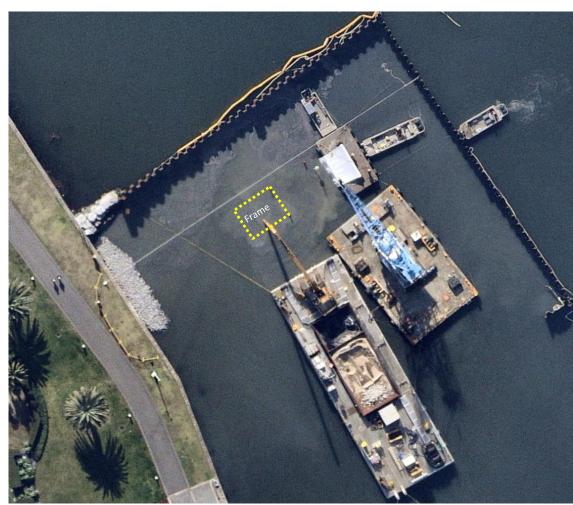
Geocomposite filled with 3.4kg/m² activated carbon

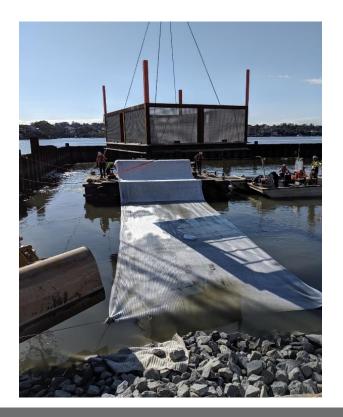
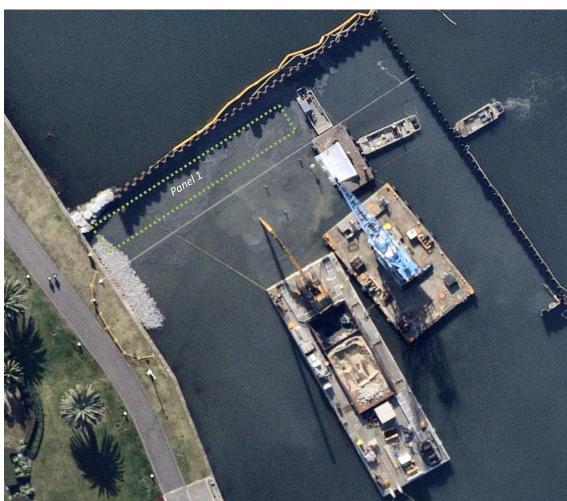
**■ Installation of 1000 m² per week**

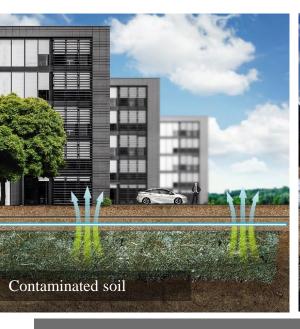
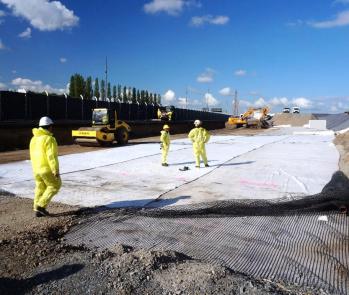
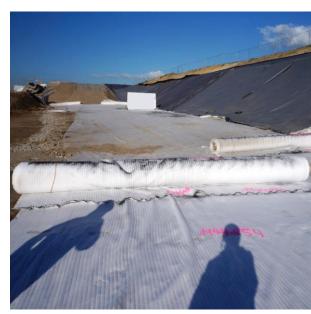
- **Permeable** filter for reuse of brownfields
  - Useful when contaminant leaching to groundwater is not concerned
  - To minimize artificial changes in water table elevation
  - Where soil moisture is needed to sustain bioremediation
  - **Where it is acceptable for vapors to diffuse to the atmosphere**

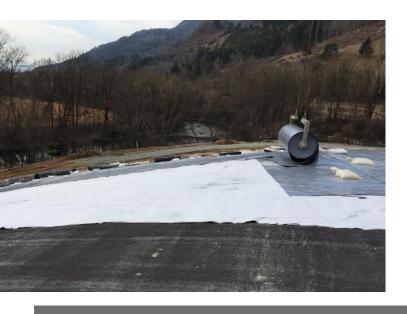
- Impermeable diffusion barrier for sites not suitable for permeable solutions
  - Where contaminants present in the unsaturated zone are likely to be mobilized by infiltrating precipitation and impact groundwater
  - Vapor capture is desirable (e.g. increased effort for methane collection)
  - **■** Release of vapors to the atmosphere is not acceptable

- Drainage geocomposite
- Geomembrane with e.g. aluminium or EvOH core
- **Active Geocomposite**

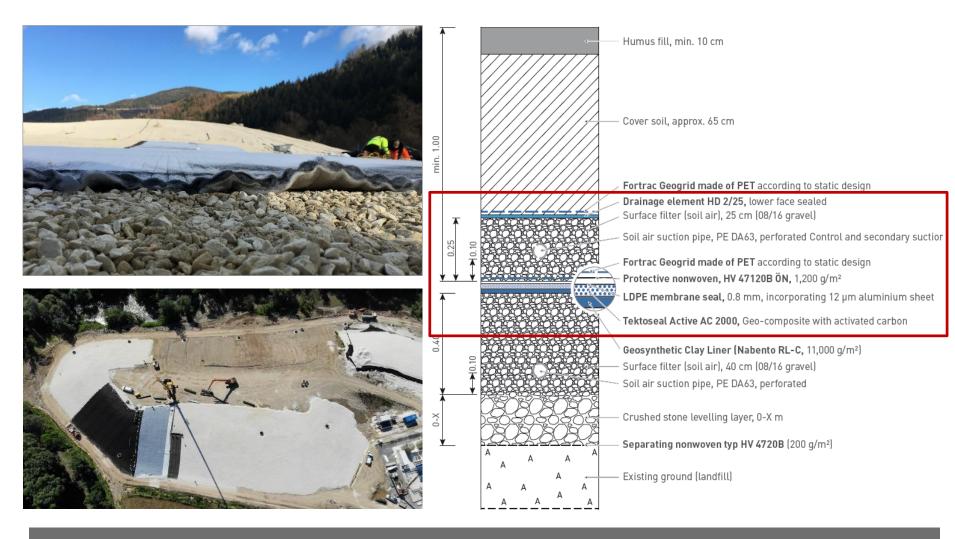
## **Sealing system with active Geocomposite**

- Filled between 1926 and 1981 with
  - Blue Chalk (By-Product from Acetylene Synthesis)
  - Ash, slag, Construction waste
  - Mercury contaminated Waste
  - Chlorinated Hydrocarbons (CHC) containing sludge and filter cakes
- In 2012/13 remediation by thermal treatment in a rotary furnace of a cement plant started
- In 2014 hexachlorobenzene was detected in locally produced food in proximity to cement plant  $\rightarrow$  excavation and treatment stopped
- Result of another pan-Europe tender: no procedure with continued clearance offers legal, technical, temporal or financial security
  - → Need for site capping
